EFFECT OF UNPROTECTED INTERIOR BEAMS ON Membrane Behaviour of Composite Floor Systems in Fire. I: Experimental Investigation

Kang-Hai Tan ^a, Tuan-Trung Nguyen ^a

^a Nanyang Technological University, School of Civil and Environmental Engineering, Singapore

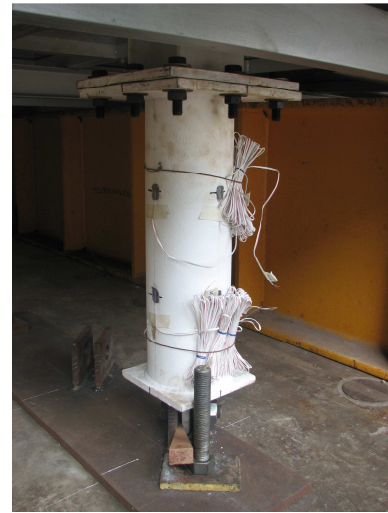
Fig. 3 Supporting columns

The edge and interior beams, which were totally enclosed inside the furnace, were able to deform freely. The specimens were connected to four supporting circular columns which were located outside the furnace and connected to the strong floor by pinned connections (Fig. 3). These pin-ended columns allow the specimens to move horizontally without any degree of restraint.

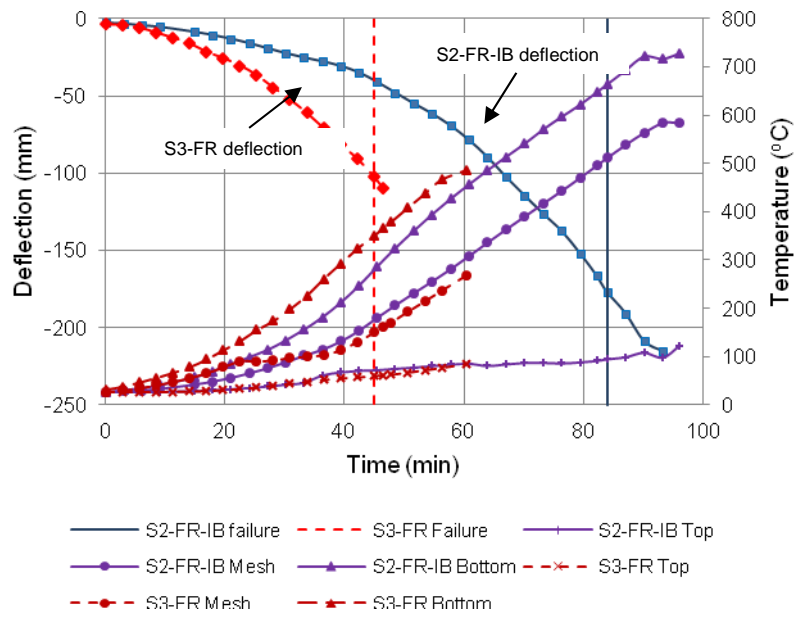
Fig. 4 Comparisons of temperatures and vertical deflection of the slabs

Fig. 4 shows the relationships between the mid-span vertical deflections and temperature, plotted against time, together with the corresponding failure points of the slabs. ‘Failure’ was considered to have occurred when there was a significant drop in the mechanical resistance, and the hydraulic jack could no longer maintain the load level (violating criterion “R”). S2-FR-IB failed at a deflection of 177mm when the mesh temperature had reached 512°C, while S3 failed earlier at a deflection of 115mm when the mesh temperature was only 150°C.

Fig. 4 indicates clearly that S3-FR experienced larger deflection than S2-FR-IB. At failure S2-FR-IB had a greater enhancement factor, of 2.55 compared to 1.54 for S3-FR. This enhancement is defined in this paper as the ratio of the test failure load to the conventional yield-line failure load at the same mesh temperature. It is obvious that the presence of interior beams significantly reduces the slab deflection and enhances the load-bearing capacity of the slab.

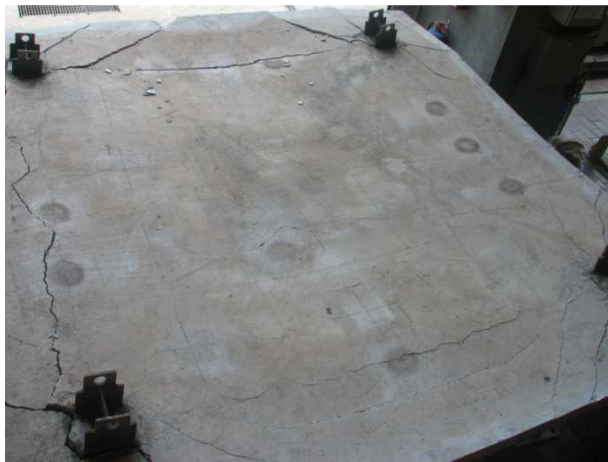
Fig. 6 Crack pattern of S2-FR-IB

In S2-FR-IB, the compression ring formed after 50min of heating. The test ended when fracture of reinforcement occurred and full-depth cracks appeared close to the edge beams, as shown in Fig. 6.

As can be seen in Figs. 6 & 7, S2-FR-IB failed because of reinforcement fracture in the vicinity of edge beams which led to full-depth cracks, while S3-FR failed because of 'brittle' failure of compression ring. Therefore it can be concluded that the interior beams have a major role in helping the slab to transit smoothly from biaxial bending to membrane behaviour. Without the interior beams, failure of compression ring may occur, resulting in less contribution from tensile membrane action in the load-bearing capacity of the slab.

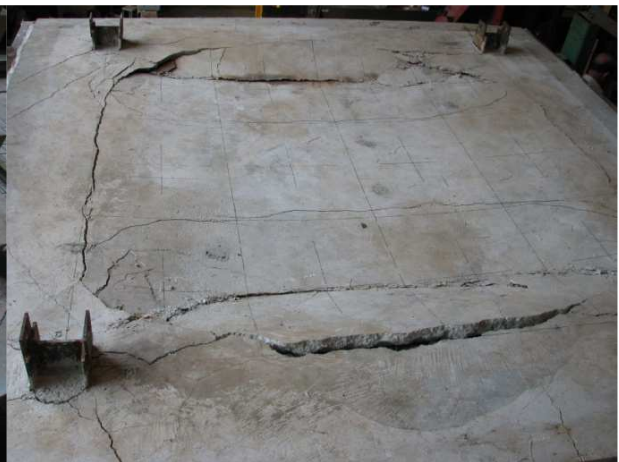
Fig. 7 Crack pattern of S3-FR

In S3-FR, the compression ring formed after 28min of heating with the appearance of curved cracks at the four corners (Fig. 7). However, at 45min three full depth cracks appeared suddenly, one at the slab corner near the column, and two above the main beams. These cracks led to 'brittle' failure of the compression ring and caused 'run-away' failure in the slab. In conclusions both of the slabs did not fail globally, but they lost their integrity and load bearing capacities (criteria "E" and "R").

At failure, the protected secondary beam (PSB) and the main beam (MB) of S2-FR-IB experienced very large deflections, 96mm and 56mm, respectively. The corresponding values of S3-FR were only 28mm and 33mm for PSB and MB, respectively. However, in S3-FR the recorded values for the main beam were not accurate. This was because severe cracks appeared at a very early stage (after only 20min of heating), directly above the main beams, as

shown in Fig. 7. Thus, composite action between the main beams and the slab could not be maintained, leading to inaccurate measurement of the beam deflection. It should be noted that the beam deflection was measured from the part of the concrete slab which remained intact and directly above the beams.
